PHOSter Case History

Lou's Quick N Easy Site

ADEM UST Incident UST02-08-05

York, Alabama

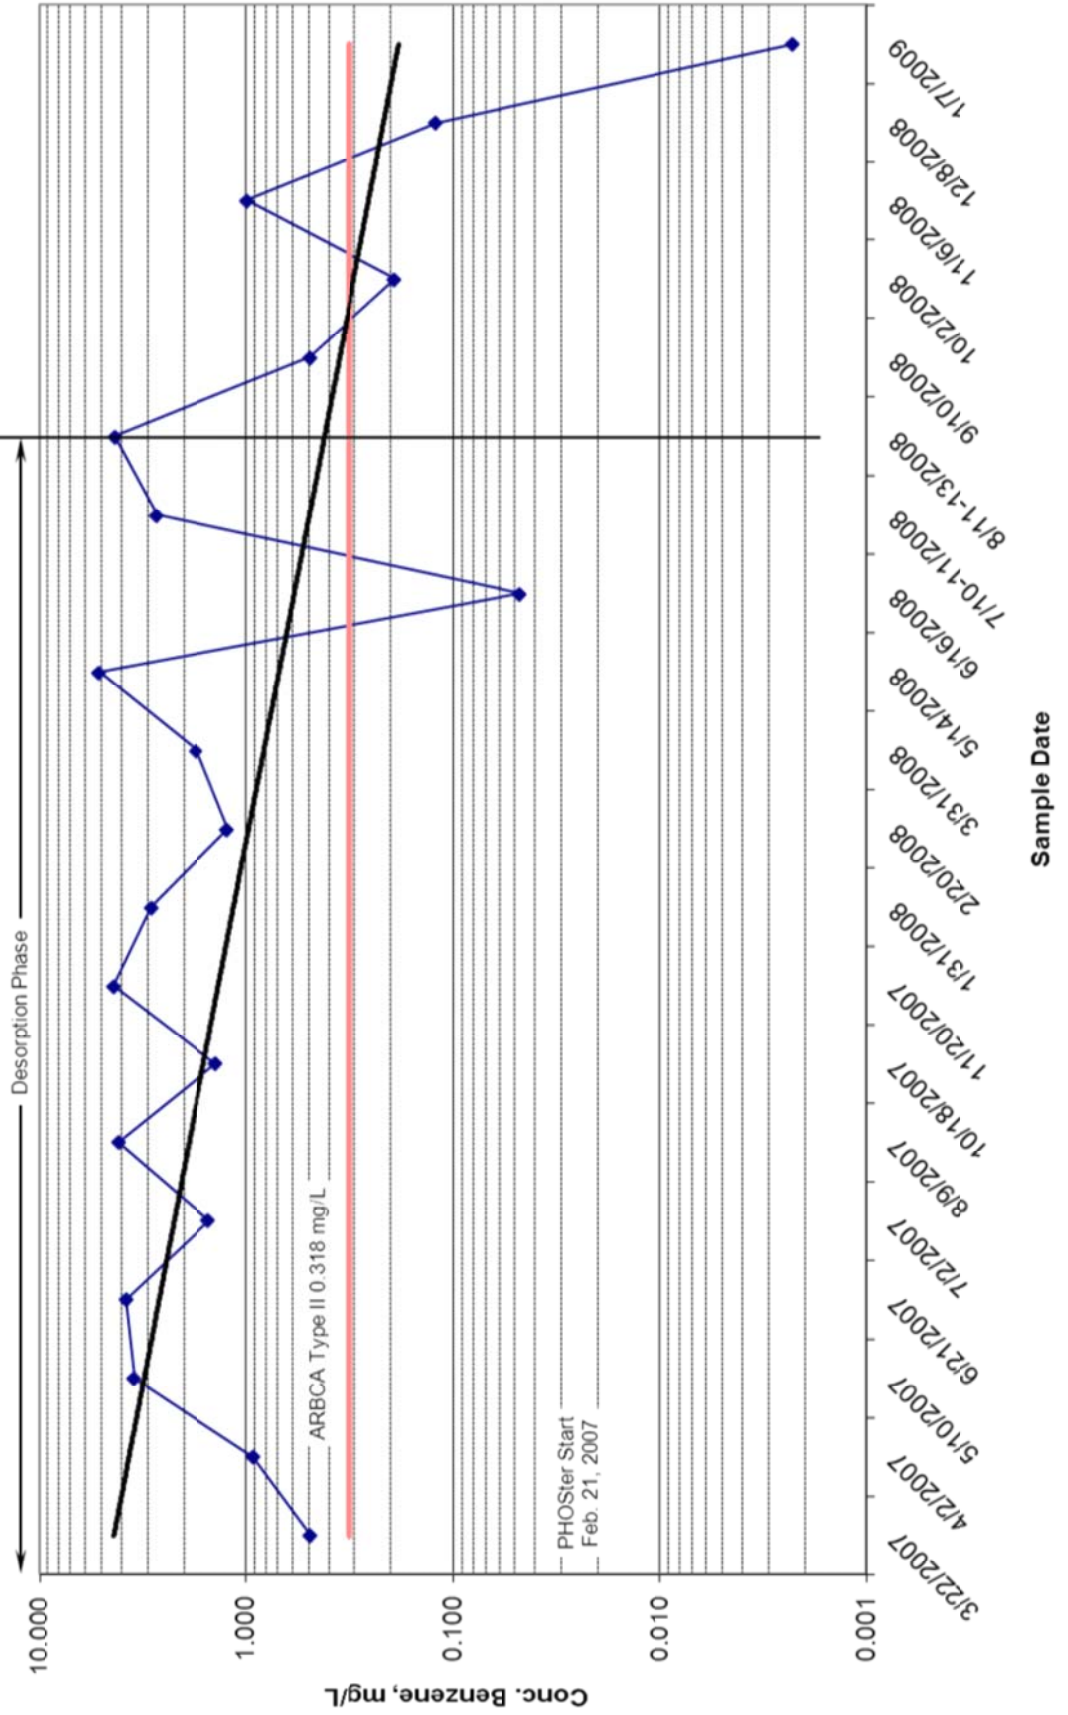
York, Alabama; MW-8

The treatment system was operated for twenty-six months until analysis indicated achievement of the SSTLs. A slight rebound of MTBE at MW-8 required a system restart and additional operation for six more months. The system was shut-down in April, 2010 and the site received an NFA after well closure in October of 2012.
