PHOSter Case History

Ron Moyer Service Center

PADER Site #589393

Camp Hill, Lower Allen Township, Cumberland County, Pennsylvania

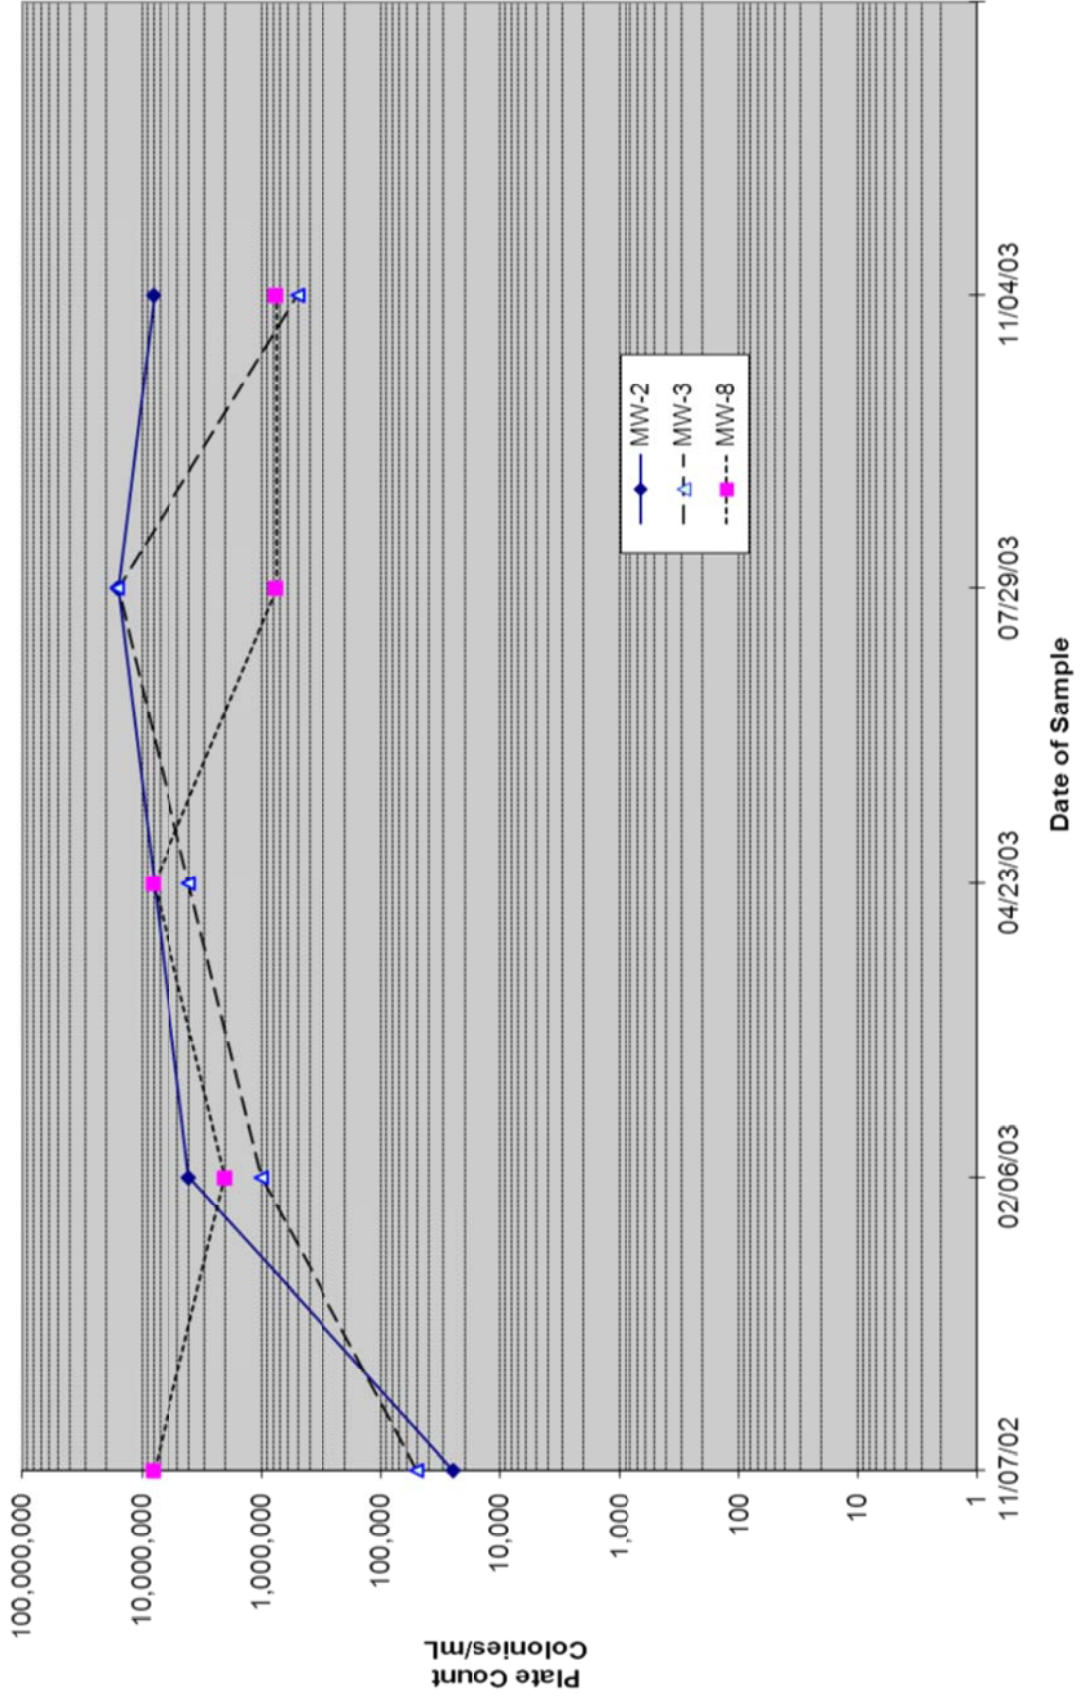
Heterotrphic Plate Count  
Ron Moyer Service Center; Lower Allen Township, Penn.

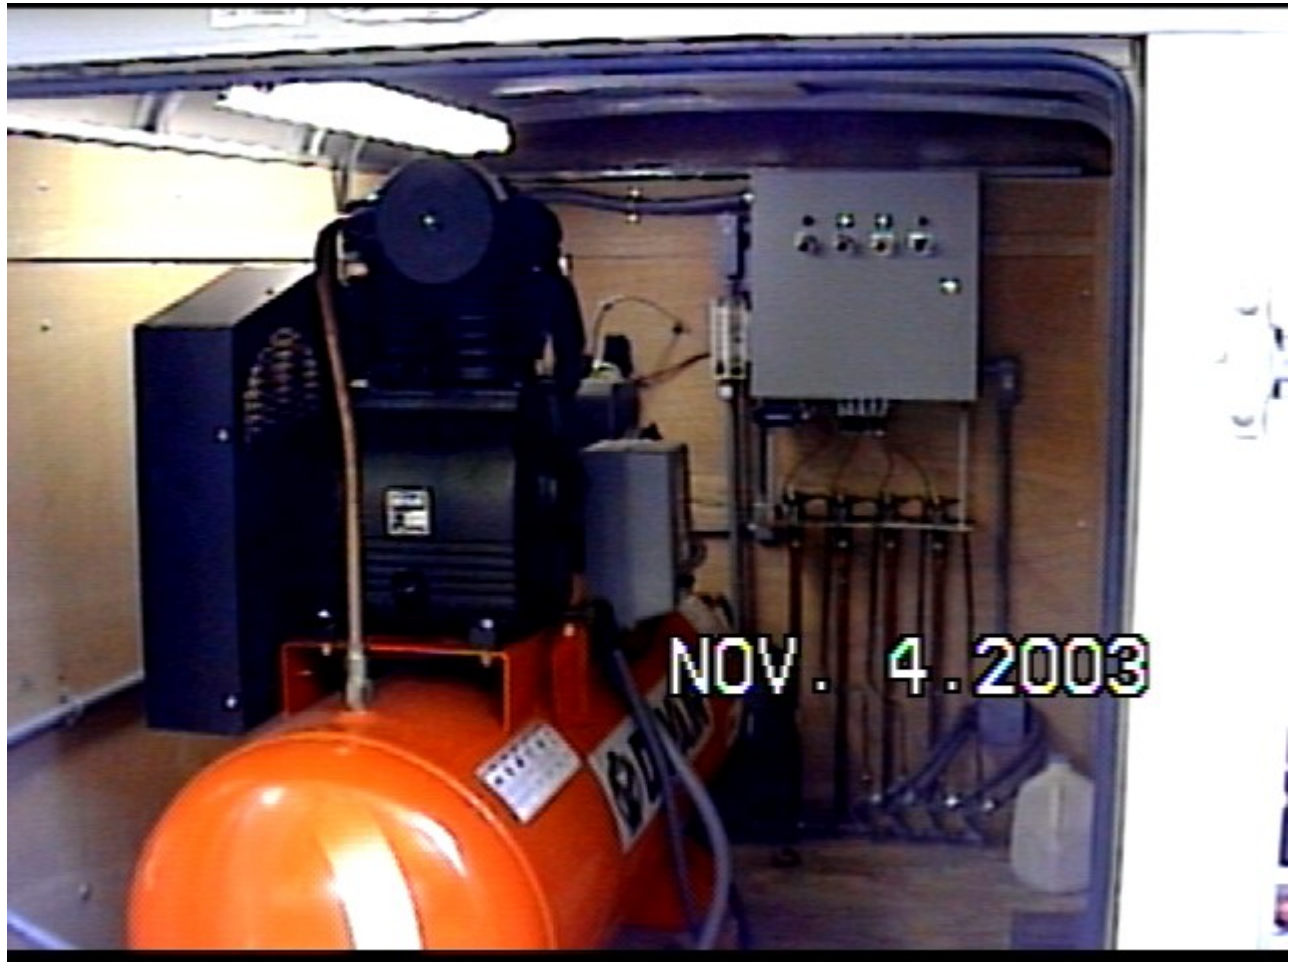
Photo 1: Interior of Four-Injector PHOSter System

Client required PHOSter remediation on the service center site and elected to install Regenesys' ORC socks in the off-site impacted wells. A four injector PHOSter trailer-mounted system was installed using a 25' design radius of influence (ROI).
